Premium Inspection Report

This inspection was conducted on November 10, 2010, at the request of the purchaser, in order to assess the existing construction of a home and other installations completed on a lot in the subdivision known as Las Olas, Dominica, in the district of Ballena, canton of Osa, in the province of Puntarenas, Costa Rica. The residence, located in Phase I of Las Olas, contains 5408 square feet under roof, and is situated on a 6649.14 square meter lot.

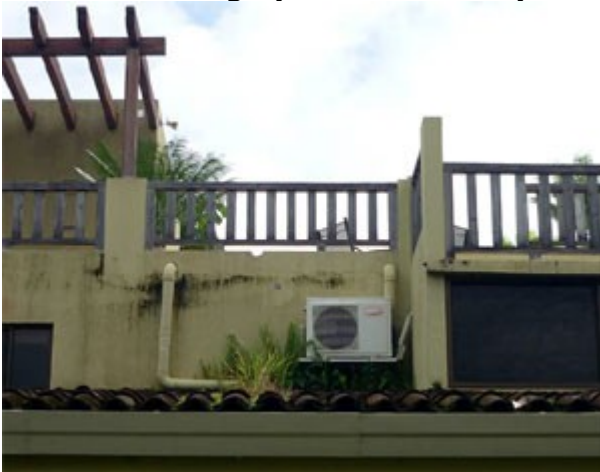
There are 4 split AC systems serving the house. Three are Yamabishi 18,000 BTU 240 watt units with two of these serving the guest bedrooms. The exterior condensing units for these systems are located on the lower path on the south wall of the home. The unit that serves the master suite is not working. The exterior condenser for this unit is located on a shelf above the ceramic tile roof of the family room, which is not an easily serviced location.

The fourth AC system is a larger split system serving the family room and kitchen and dining areas. The fan unit is located in the attic mechanical access above the kitchen pantry and

insulated forced air and return air venting is also located in this space. This unit is controlled with a Trane branded remote control, but there is no brand evident on the unit itself, which is located on the lower path on the south wall of the home. The metal base of this unit is badly corroded. The vent in the dining room exits through the attic mechanical access above the kitchen pantry to

the master bedroom deck. This exit vent is camouflaged with a box made from Fibrolit and exterior Densglas drywall however it is in poor condition due to water infiltration.

The metal base of the largest unit is corroding and should be replaced

Rebuild exterior venting box between kitchen and dining room or remove if dining room can function without AN A/C vent

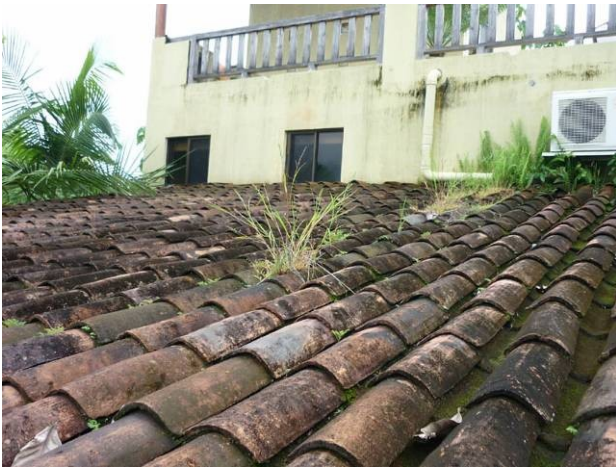
This roofing covers the guest wing, family room and employee quarters wing. The guest wing is intact with the only issue being a better cap needed to cover the upper edge of the roof adjacent to the entry walkway. It is currently open to wind driven rain as evidenced by 2 small water damage spots, one in each guest bedroom.

The family room roof has numerous broken tiles and water has penetrated below, then run down the sealed insulation and caused water damage in the soffit area below. There is also a lot of mold and plant life growing on this roof.

Guest Wing - Properly install galvanized flashing or two horizontal rows of tile.
 Family Room – Remove all broken tiles, inspect galvanized roof for penetration, repair and re-tile as needed. Relocate A/C condensing unit.

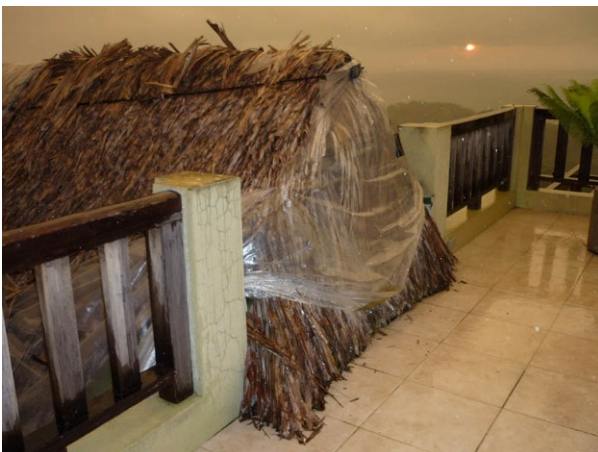
2. Palm Thatch Roofs – Palm thatch and wood beam roofs are installed above the outside living area, carport and pool swim deck. All have visual openings and obvious water leakage. The outside living area palm roof is covered in plastic tarps and the carport has corrugated metal on top of the thatch to minimize leaks. The wood beam supports appear to be in good condition, with the exception of an active termite tunnel on the southeast support of the carport.

Based on the visual evidence of active termites, treat all exposed wood.

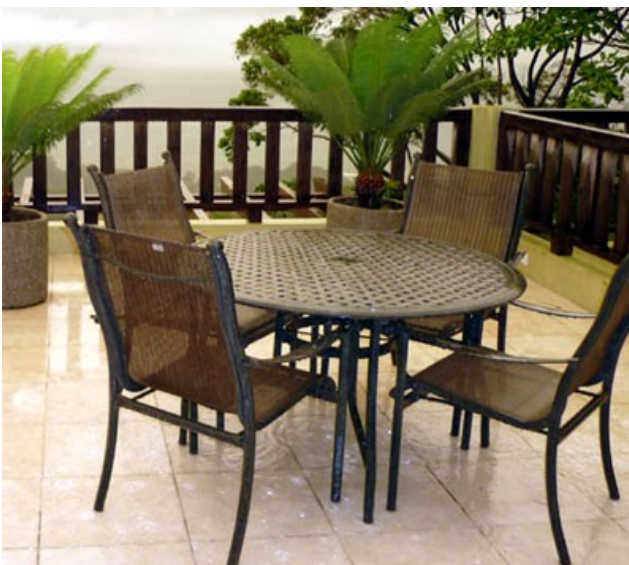
2. Flat Roofs – Exposed concrete is the base of the master bedroom, moon and adjoining decks. These roofs are the largest contributor to water problems in the home. The decks do not drain well and where the deck floors intersect the walls, moisture leaks to the exterior walls beneath the finish, separating the cement and stucco paint on both the outside and interior of home. This is evidenced by mold, loose finished surfaces and interior and exterior water stains. There is also a large, flat skylight inset into the concrete wall structure covering the stairwell and guest bathroom. It is framed in wood and made from clear plastic corrugated panels. It has flashing at all edges and drains to the exterior of

the south wall. There is evidence of mold between panel sections and there is a potential for future problems with this design.

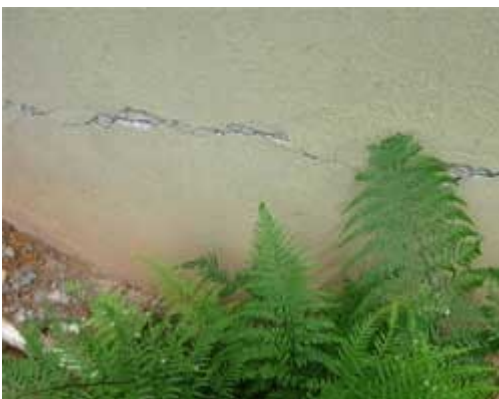
This inspection found no structural deficiencies with the exception of the west pool retaining wall.

All walls are straight and plumb with no signs of movement and all block cells appeared to be filled with concrete. After a thorough examination, no structural cracks were found anywhere on the property with the exception of a 10" long horizontal crack located in the south west end of the pool retaining wall. The crack is 6" below the bottom of the pool floor and is a serious structural defect in the retaining wall that should be addressed.

Upon excavation of a 3" diameter area at the midpoint of the crack, moist cement and loose rock aggregate were discovered. A 3/4" wide, 12" long chisel easily penetrated the crack 8" deep. No structural steel was located. The

My opinion is this crack is due to improperly mixed and cured concrete. No surface area wet spots were located in the area that would indicate a pool leak.

Drain the pool and excavate all loose material, verify structural reinforcing steel and re-pour concrete in the affected area. Remove the pool piping located in the front of the existing wall,

install footing, pour a 12" deep x 2' high concrete wall in front, utilizing #4 reinforced steel to mechanically tie it into the existing wall.

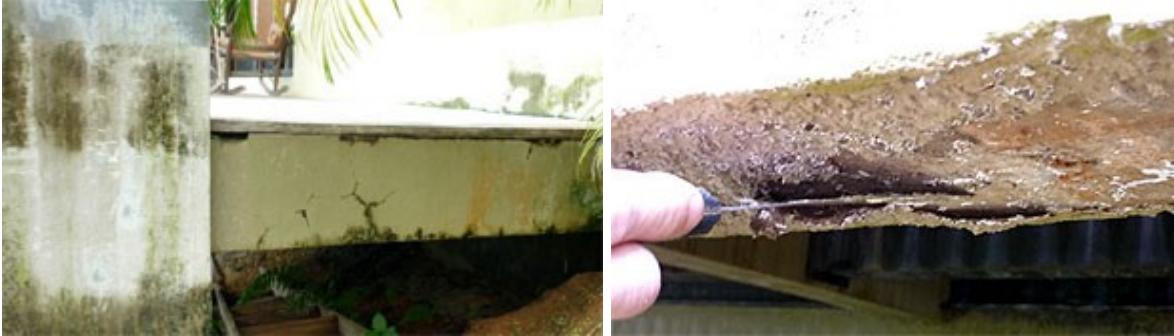
The lower, south side exterior has multiple areas of water infiltration and stucco separation due to drainage issues from the deck above.

A narrow, part gravel and dirt and part concrete path leads along a sharp drop off to mechanical systems and pool mechanical room under the deck. Retention landscaping and/or a retention wall was not installed in this area and it is rapidly eroding, **see Water Drainage Summary**.

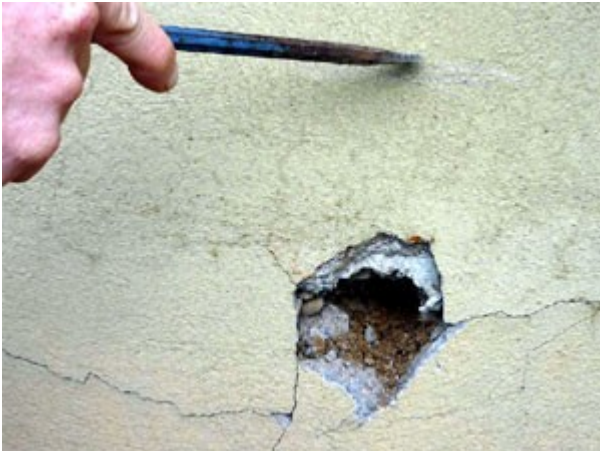
This is comprised of a concrete support wall for the pool, a concrete sidewalk running the length of the side, a small strip of grass and the back property retaining wall. The concrete wall supporting the pool was closely inspected and the area of concern noted by the client was determined to be below the pool floor. In the picture to the right, the tool is marking where the bottom of the pool is in relation to the concrete damage. **See Structural Integrity Summary.**

In viewing the house from this angle, it was noted that there are exposed electrical wires hanging outside the family room over the pool, **see**

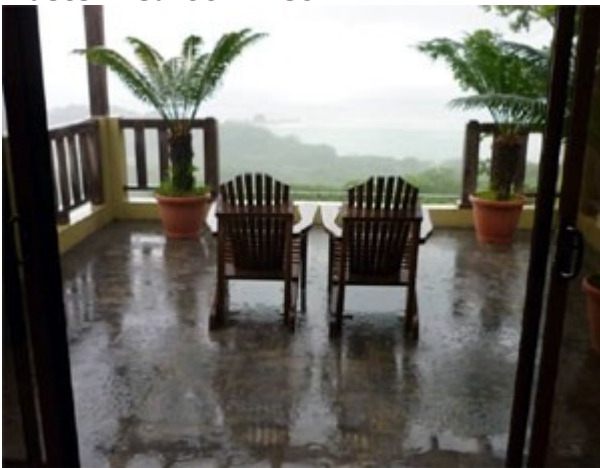
Accessible only through the master bedroom, this 12' 10" x 14' 2" deck is tiled with 12" x 12" slate tile and has a concrete post and wood rail with front glass panel for an unobstructed view. It has a decorative wood post and beam top, making it fully exposed to rain. There is wiring on two of the concrete posts for outdoor lighting, but no fixtures and the wiring is currently covered with black plastic. There are also two electric receptacles which are fully exposed to the elements but are not rated for outdoor use. It was raining during the inspection and standing water was evident on the tile. There is a single tube drain installed into the stucco which cannot handle a large amount of water and it is assumed that this is part of the

water leakage problems the house is having. **See Roofing System Summary.**
