Standard Inspection Report

This inspection was conducted at the request of the purchaser in order to assess the existing construction of a home completed on lot 1, condominium La Hacienda in the canton of Barva, province of Heredia, Costa Rica.

This single-family home located in the district of San Clemente contains 125 m², 1781 square feet of well finished construction, not including the roof overhangs. The home has 4 bedrooms, 3 bathrooms, skylight room, great room, kitchen, dinette, laundry, front porch, rear terraces and carport. This house was built with concrete block and a steel roof structure.

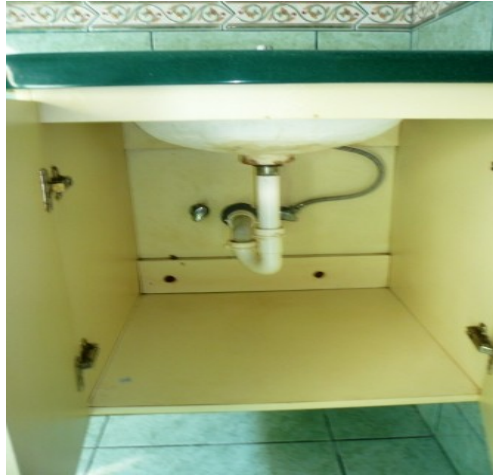
Plumbing system is working properly with no leaks or obstructions and all water outlets have good cold and hot water pressure except the master bathroom sink which needs a hot water tube connected from the faucet to the control valve.

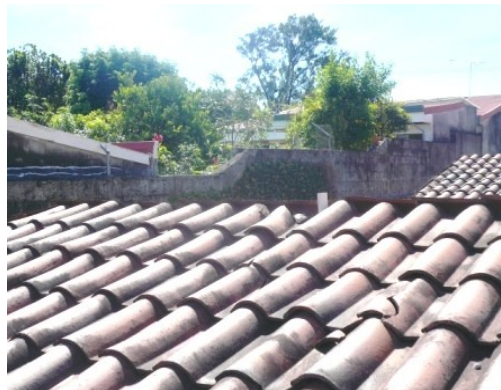
A ventilation pipe is visible protruding from the roof, however there is no top or curved PVC trap to prevent rain from entering. Additionally, in this photo you can see a cracked roof tile.

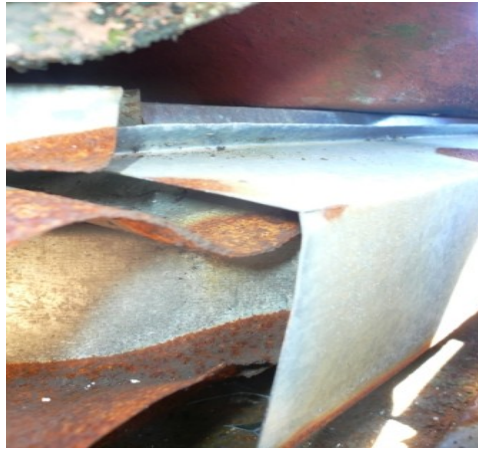
I was impressed with the installation of galvanized metal drip edge flashings installed over the edge of the roofing underlayment into the gutters. This is hardly ever installed in Costa Rica. In this same photo you can see the corroded roof underlayment.

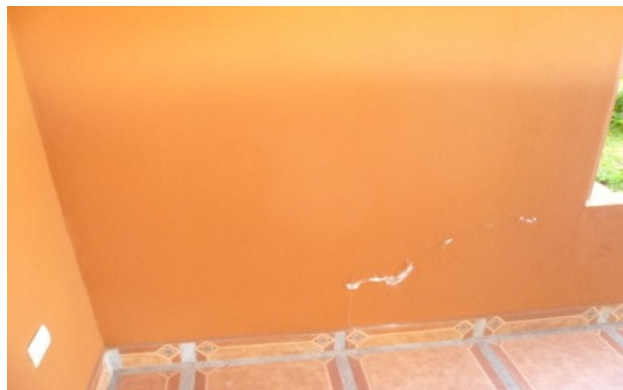
The garage wall that is connected to the right side neighbor's wall has obvious deterioration of the stucco surface from excess moisture.

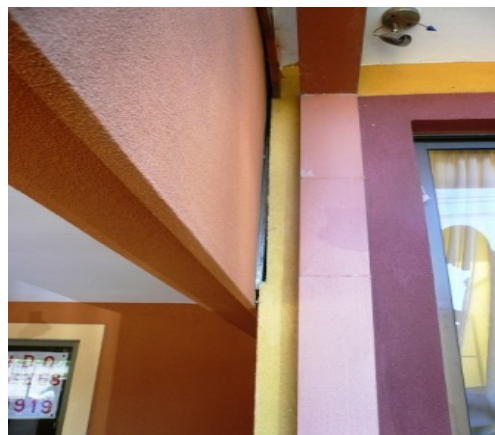
I checked the moisture content with my moisture meter and found that the lower portion of the wall which is below the grade of the neighbor's front yard, had 6 to 8% moisture while the upper wall had only 2%. There are two areas where water infiltration could be occurring.

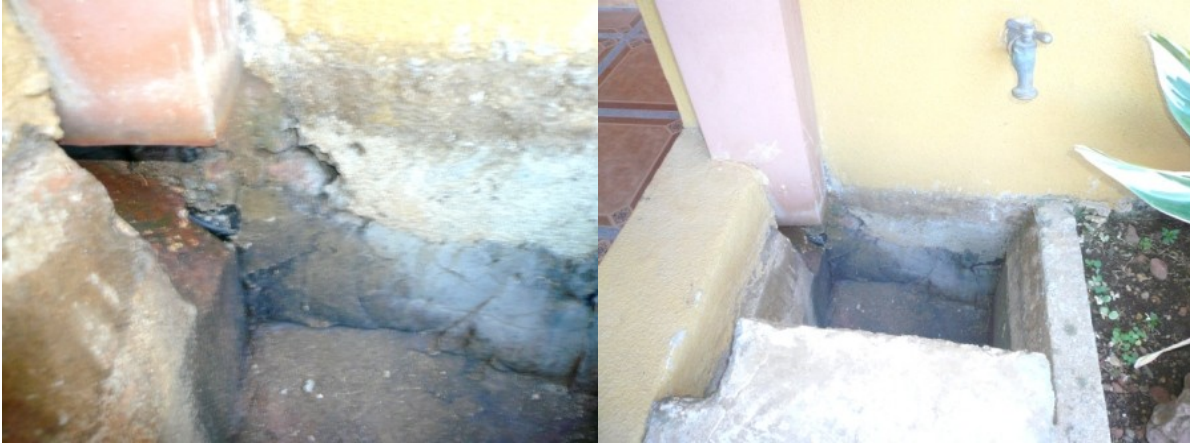
Between the neighbors exterior wall and this homes carport wall is a gap of about 1" that is open and water can drain from the roof and into the open wall cavity. This gap can be easily filled with a small piece of the exterior siding and then plastered and painted to match the existing finished wall.

The other area where water is infiltrating is in the concrete clean out box where the concrete was never finished and a hole is visible. This can be plastered with concrete in order to close the hole so the water can no longer enter there.

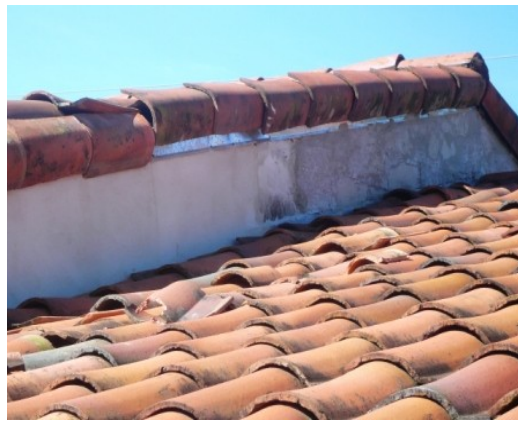
Additionally, on this same adjoining wall, up above the roofing tiles, the concrete plaster was never finished. Since this wall comes into direct contact with rain, the moisture will accumulate in the concrete wall and eventually flow down into the wall below. This can be plastered with the same exterior stucco product that was used to finish all the other walls.

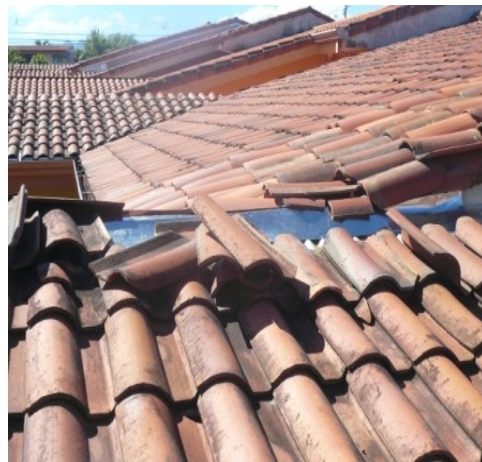
In this same wall shared with the neighbor, new galvanized ridge flashing has been installed, but the clay roof tiles were never re-installed on top of the flashing. In this photo, you can see loose tiles, some of them broken. Some new tiles would need to be obtained to replace the broken and then the roofing tile re-installation can be completed.

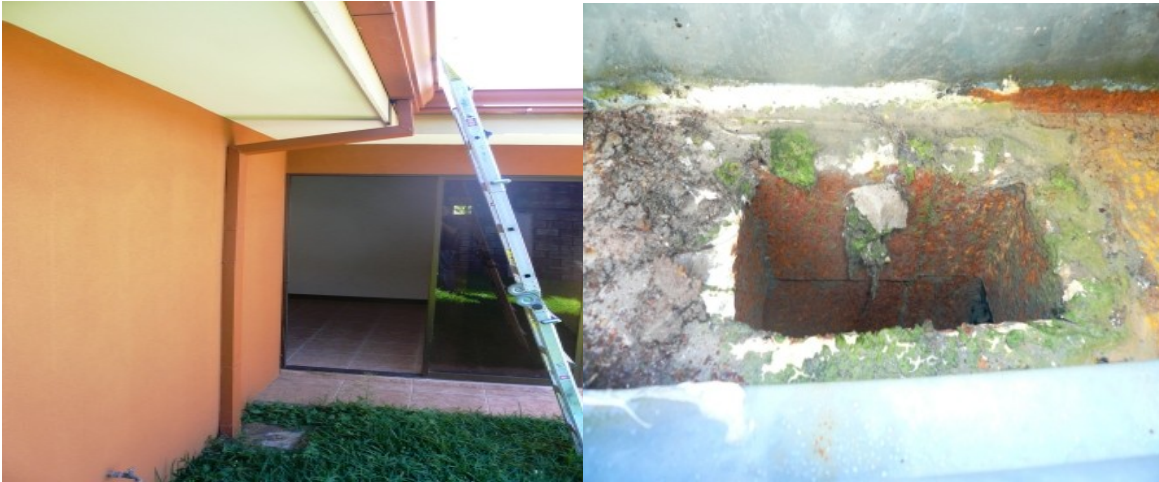
On the rear of the home there is only one small, 13cm x 6cm downspout that drains the gutters for the majority of the roof on the rear of the home. The opening of this downspout inside the gutter is only 5cm x 11cm. This small downspout does

not allow the gutters to drain efficiently during intense rains and they will overflow onto the fascias and soffits causing water damage. I suggest adding two additional downspouts on both corners of the rear roof overhangs.

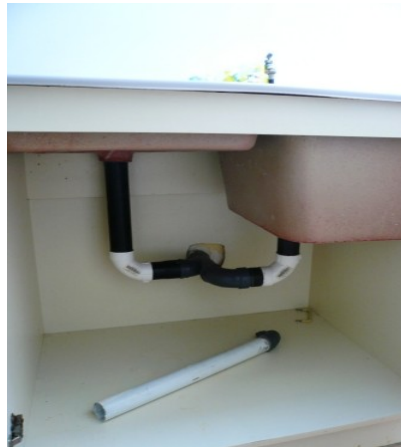
When entering the laundry room, I smelled sewer gas odor. Because there are no U traps in the laundry sink or washer drain lines, the gases can enter and cause the odor. New U traps would be easy to install.
