# Property Inspection Report

## LEGAL DESCRIPTION & PLOT PLANS OF THE PROPERTIES

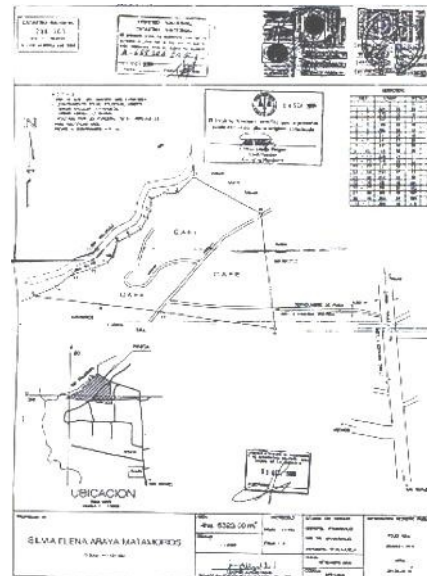
- Inscription: Folio Real 2-00011604-000
- Owner: Nunca Disponible S.A.
- Cedula : 3-101-464628
- Description: Land for Agriculture
- Plano: A-1168185-2007
- Area: 23,801.74 m<sup>2</sup>
- Province: 2 Alajuela
- Canton: 6 Naranjo
- District: 1 Naranjo
- Location: San Rafael

- Inscription: Folio Real 2020461-000
- Owner: Nunca Disponible S.A.
- Cedula: 4-142-152
- Description: Land for Agriculture
- Plano: A-658346-2000
- Area: 46,323.00 m<sup>2</sup>
- Province: 2 Alajuela

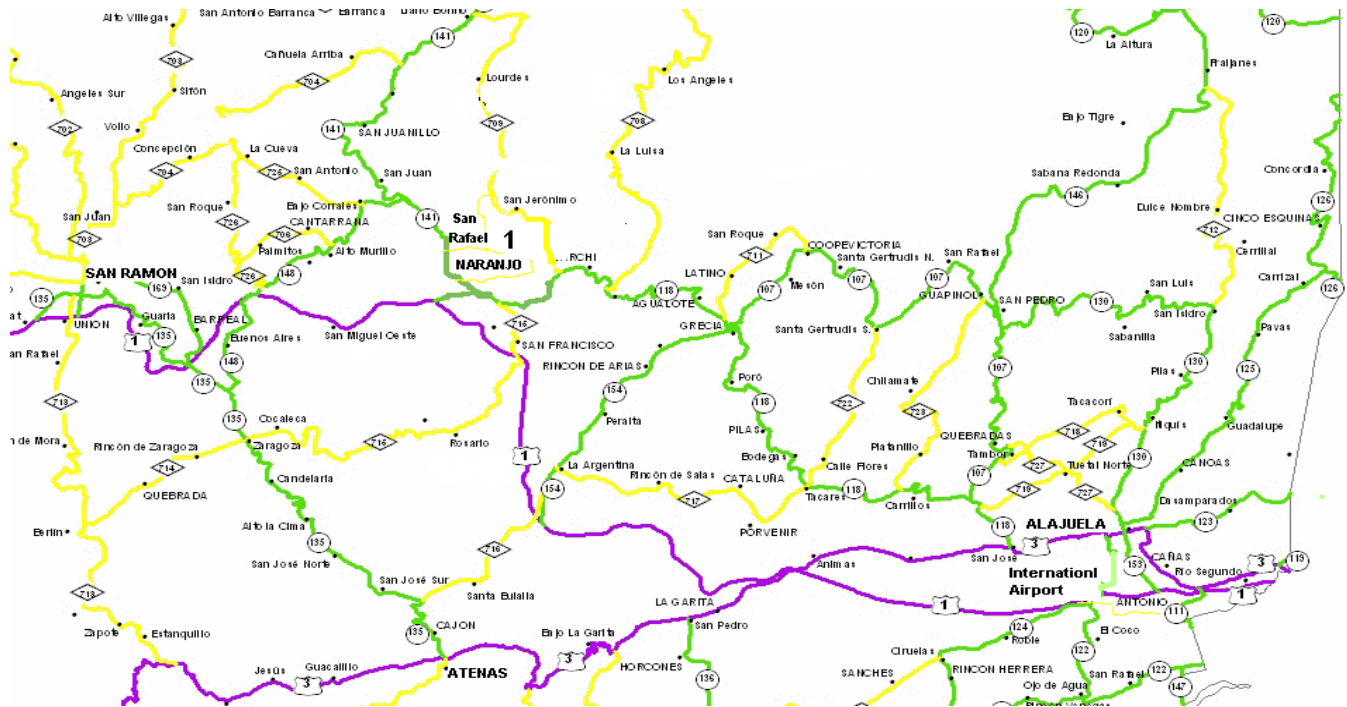
The properties referred to in this study are located in San Rafael de Naranjo and in the above map number **1** corresponds to the property location. The county map below, positions the location of the property in the community of San Rafael in relation to the closest population center of Naranjo.

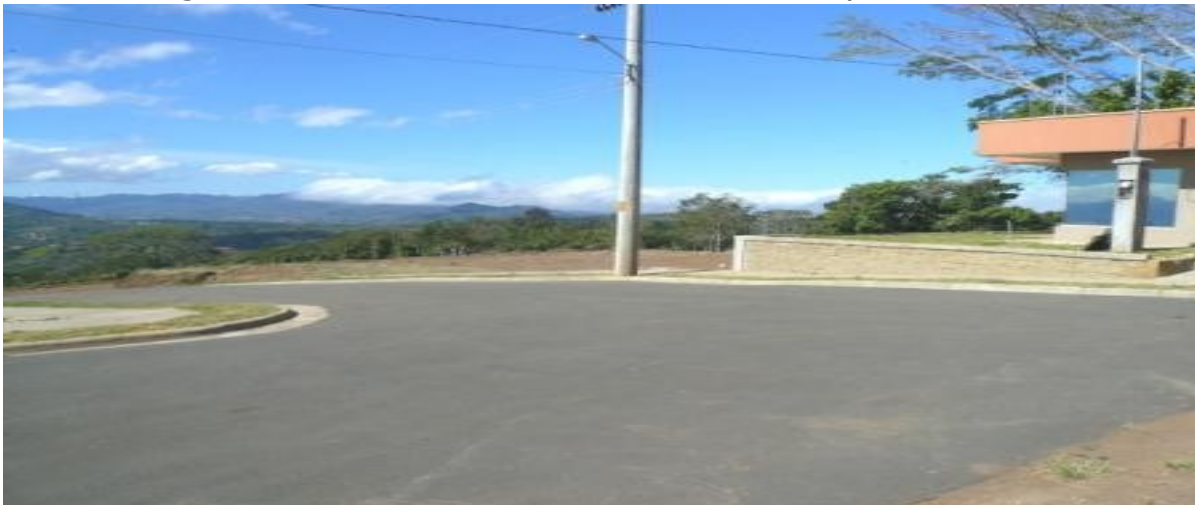
Furthermore, the access right of way indicated on the plan is only four meters wide and yet during a meeting in the municipality of Naranjo, we were told that this easement (servidumbre de paso) is seven meters wide. A four meter wide access road is narrow when drainage, curb and gutters are included and this could limit the future development of the parcels of land that the public right of way services.

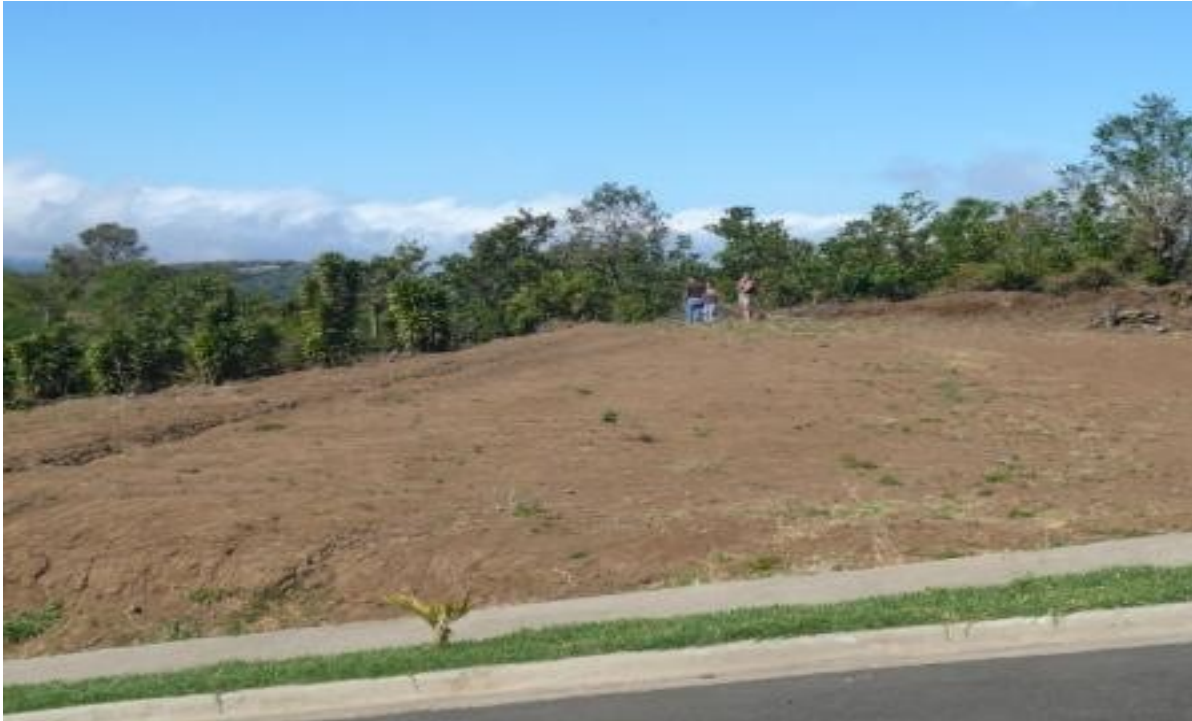
The external boundaries of this property are easily identified from the adjacent land by posts, a border of trees and the river below. With respect to the topography, the top portion of the property maintains gradual sloping elevations, north to south, and ideal for construction. Along the eastern frontage, bordering the neighboring property that has been cut for individual lots is where the inspected property could be cut into building sites for cost-effective construction of the purchaser's project. The western side of the property slopes down to the river frontage, offering natural privacy suitable for nature trails and other activities. The western slope of the property would be suitable for construction as well; however, the cost for the foundations would be greater than on the flatter terrain on the top portion of the property.

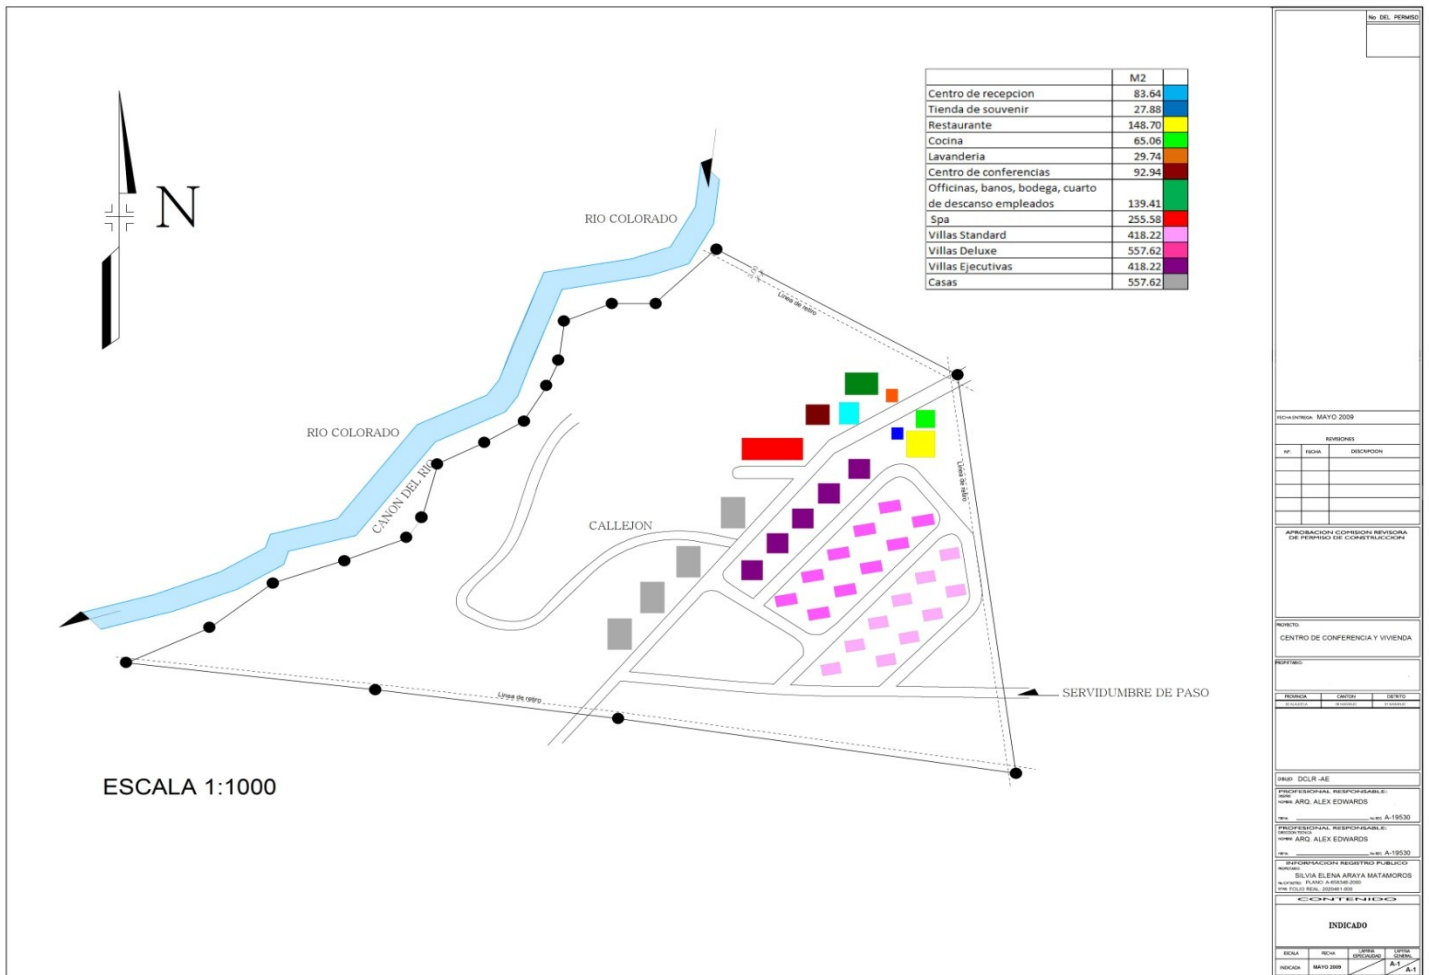
The following site plan details the housing construction and support structures that I recommend for this project. I created this plan from the developer's description of the project he envisions and the land use commitment letter I obtained from the local municipal government.

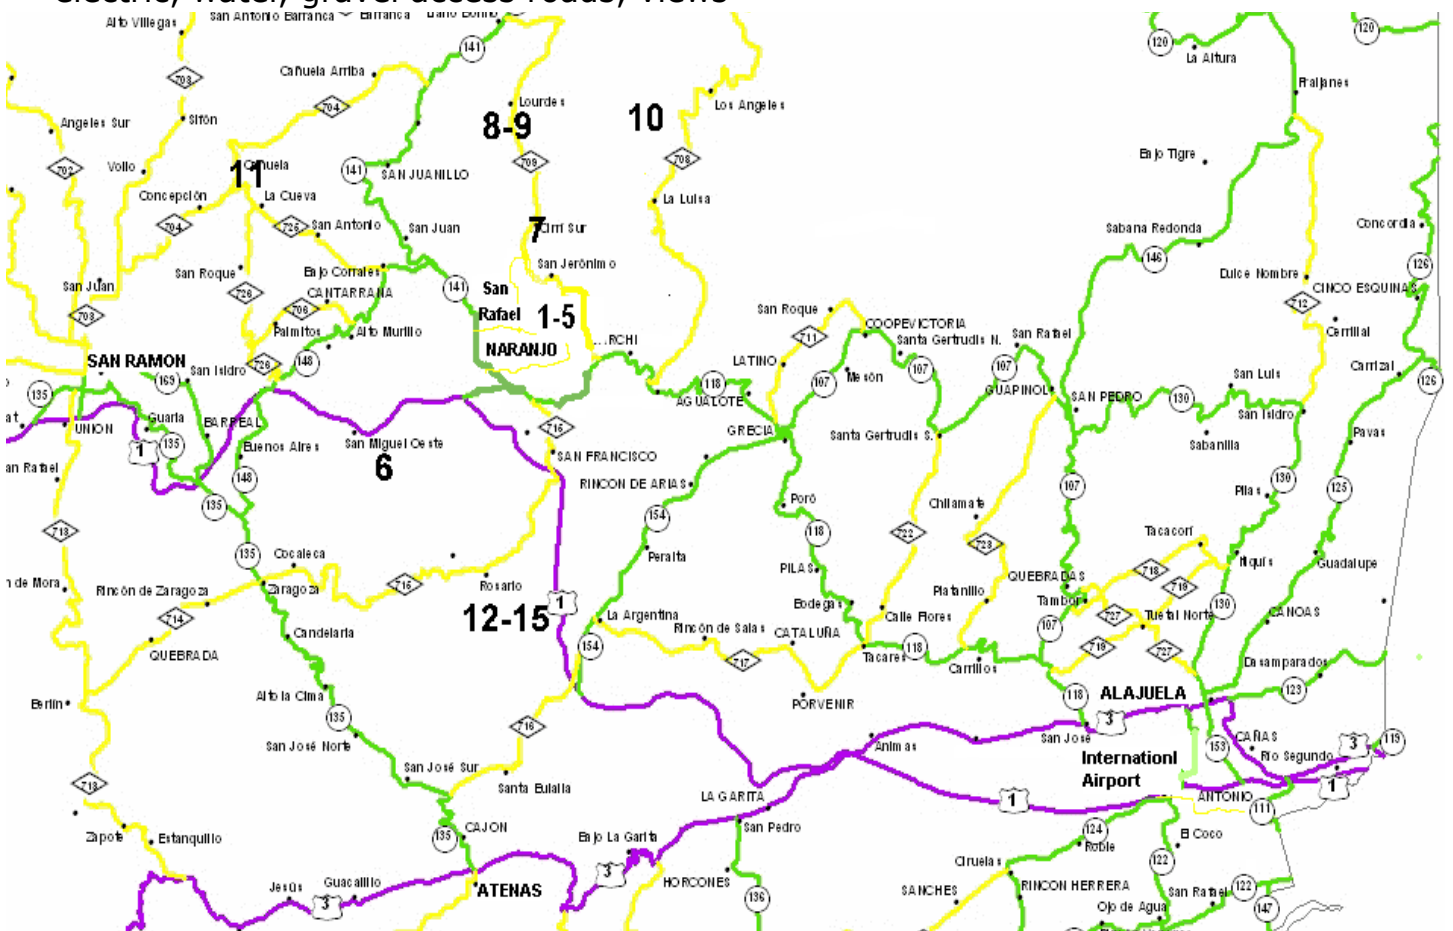
The following comparable properties are described and numbered on the map below:

1. **Inspected Property. Size 70,124.74 M2**
2. Lots 1000m2 @ \$30.00m2, electric, water within 100 meters, gravel road, views
3. Two adjacent parcels to the inspected property. Size 66,297.77m2 @ \$7.50m2, electric, water within 150 meters, minimal views, dirt access road.
4. Parcel 25 meters SE of property inspected. Size 39,543.50m2 @ \$4.27m2, electric, water within 150 meters, minimal views, dirt access road.
5. Lots 50 meters SE of property inspected. Size 2679m2 @ \$40.00m2.
6. Parcel of 30,000m2 @ \$10.33m2., electric, water within 150 meters, views, gravel access road
7. Farm 208,349.22m2 @ \$4.50m2., electric, water, paved to the property, views.
8. Lot 4245m2 @ \$11.51m2, underground electric, water, phone line, paved to the lot, views.

9. Lots 1000m2 @ \$30.00m2, electric, water within 100 meters, gravel road, views
10. Farm 764,700m2 @ \$1.57m2., electric, water within 500 meters, gravel roads, views
11. Farm 129,925m2 @ \$25.00m2, electric, water, paved to farm, views
12. Farm 35,000m2 @ \$9.40m2, electric, water, paved to entrance, views
13. Farm 15,348m2 @ \$11.00m2, electric, water within 200 meters, gravel access road, views
14. Lots from 5000m2 @ \$35.00m2, Plantation Estates, gated, electric, water, gravel access roads views
15. Lots from 3000m2 @ \$75.00m2, Hotel Vista del Valle, gated, underground electric, water, gravel access roads, views
