Property Inspection Report

LEGAL DESCRIPTION & PLOT PLANS OF THE PROPERTIES

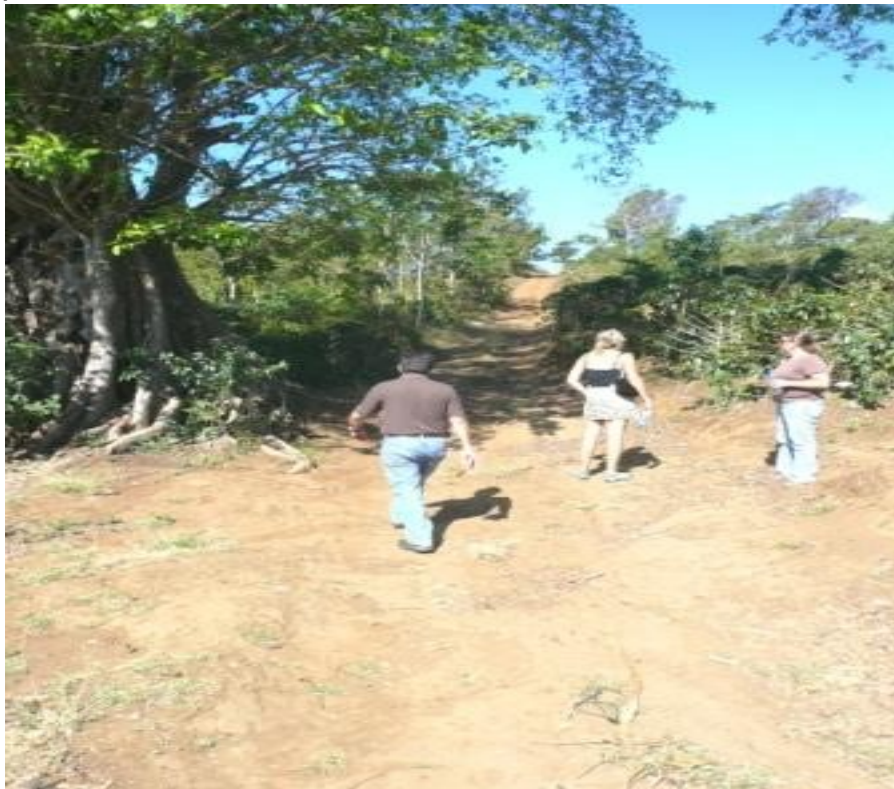
Access to the properties is from a roughly leveled dirt right-of-way easement off an asphalt-covered public street.
