Premium Inspection Report

This inspection was conducted on November 10, 2010, at the request of the purchaser, in order to assess the existing construction of a home and other installations completed on a lot in the subdivision known as Las Olas, Dominica, in the district of Ballena, canton of Osa, in the province of Puntarenas, Costa Rica. The residence, located in Phase I of Las Olas, contains 5408 square feet under roof, and is situated on a 6649.14 square meter lot.

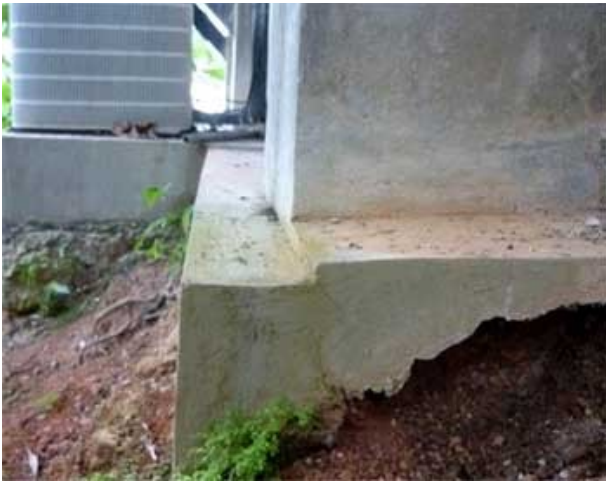
All walls are straight and plumb with no signs of movement and all block cells appeared to be filled with concrete. After a thorough examination, no structural cracks were found anywhere on the property with the exception of a 10" long horizontal crack located in the south west end of the pool retaining wall. The crack is 6" below the bottom of the pool floor and is a serious structural defect in the retaining wall that should be addressed.

Upon excavation of a 3" diameter area at the midpoint of the crack, moist cement and loose rock aggregate were discovered. A 3/4" wide, 12" long chisel easily penetrated the crack 8" deep. No structural steel was located. The

My opinion is this crack is due to improperly mixed and cured concrete. No surface area wet spots were located in the area that would indicate a pool leak.

Drain the pool and excavate all loose material, verify structural reinforcing steel and re-pour concrete in the affected area. Remove the pool piping located in the front of the existing wall,

install footing, pour a 12" deep x 2' high concrete wall in front, utilizing #4 reinforced steel to mechanically tie it into the existing wall.

While the pool is drained, work required on the west end of the home's exterior can be more readily accomplished and the pool can also be acid washed to remove the blue stain from the grout, if desired.

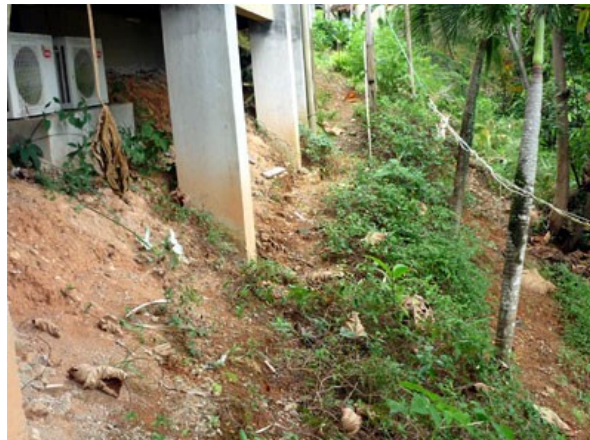
The lower, south side exterior has multiple areas of water infiltration and stucco separation due to drainage issues from the deck above.

A narrow, part gravel and dirt and part concrete path leads along a sharp drop off to mechanical systems and pool mechanical room under the deck. Retention landscaping and/or a retention wall was not installed in this area and it is rapidly eroding, **see Water Drainage Summary**.

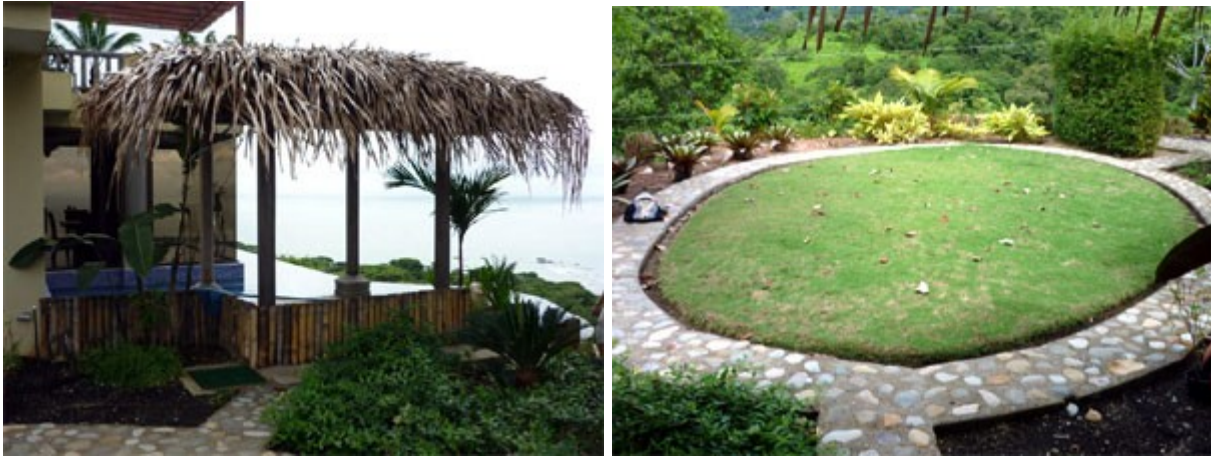
On the north side of the property is a 12' x 9' foot covered wood gazebo with wood and concrete supports and thatched roof, 7 1/2' x 7 1/2' attached wood deck over the pool and a bamboo border. The thatched roof needs repair. A large concrete rainwater drain with metal grate is adjacent to the gazebo, as is a working outlet junction box.

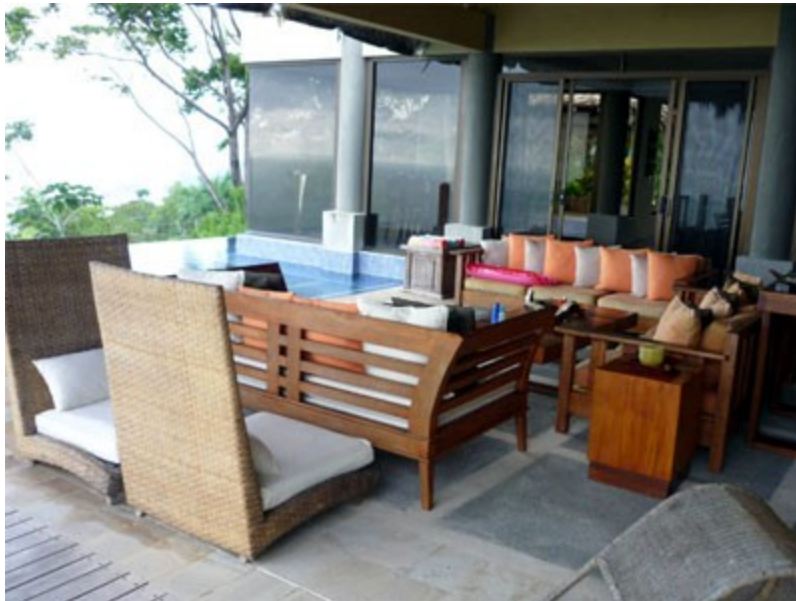
That said, the room does have issues. The glass walls are leaking at the base from the sill, there are water stains at the right concrete column and there is a water leak in the ceiling at the A/C vent. **See Windows and Doors and Roofing Summaries.**

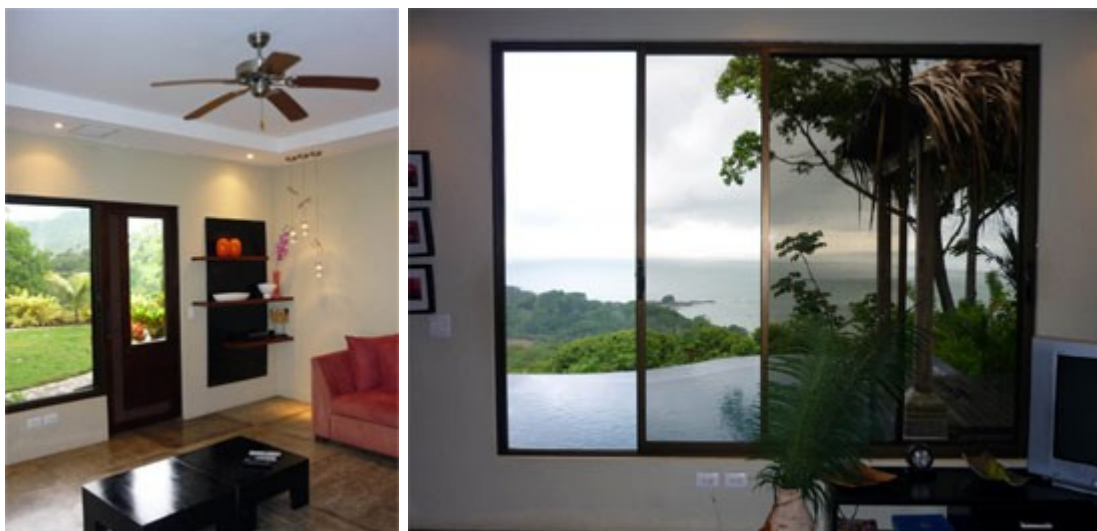
center, with a border surround of natural stone tile. There are 4 ceiling fans and a total of 8 spotlights and 2 recessed lights. Facing the room from the kitchen, there is a brick red painted stucco wall with an attractive, exotic wood panel to the left. All of the fan and light switches, 3 receptacles and two data outlets are located on this wall and the ceiling in this section only is drywalled. Directly ahead is the teak deck leading to the guest wing. The railing around the living area is two foot glass panels with wood posts set into decorative concrete bases. The view is of the jungle. To the right is the pool area, with a deck bump out measuring 7' 6" x 6' and ocean view. The thatched roof is in poor condition, and has been covered with plastic, which is torn. **See Roofing System Summary.**

Along the west side of the outdoor living room are numerous cracked tiles appearing along the line where the foundation wall meets the concrete floor slab. This is most likely due to slight settling and the slab not being tied to the foundation wall. Both surfaces are level to each other and the foundation wall is straight and solid with no evidence of defect. To repair, remove all tile along the floor/wall joint and retile to edge of deck slab. Tile the portion above the wall separately as a border and use the new grout line as a separation point.

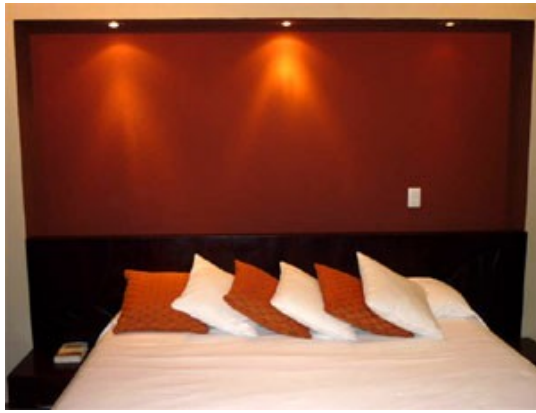
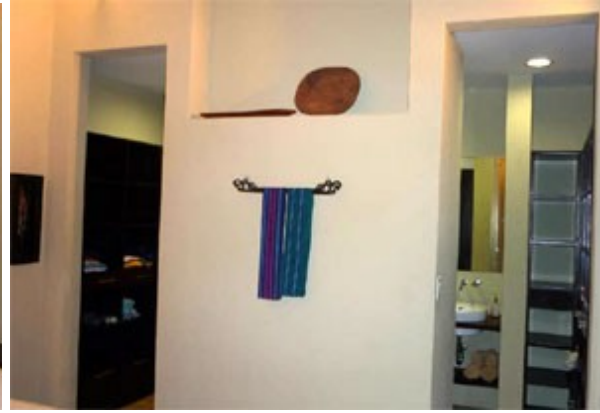
This 14' x 14' room is reachable directly from the deck through a set of 12' high quality sliding glass/screen doors with full length fabric curtains, through a small foyer dividing the two guest bedrooms with a solid wood entry door also leading to the deck and through the guest bath. It has an attractive stained concrete floor in a diamond shaped pattern, vaulted ceiling, an operable 5 blade ceiling fan, an operable Yamashibi split A/C system, built in wood closets and 5 wall sconces with 4-way switches and dimmer. There is a 10" x 30" fixed pane, 2 light window to the top of the painted stucco wall above the matched set of double sleigh beds. There are 5 electrical receptacles with one needing repair and 2 telephone and 2 data receptacles. Full length curtains cover the sliding glass doors. Water damage was noted above the window, **see Roofing System Summary.**
